A Case Study in Implant Aesthetics

By Rhys Spoor, DDS, FAGD
Accredited Member of
the American Academy of
Cosmetic Dentistry

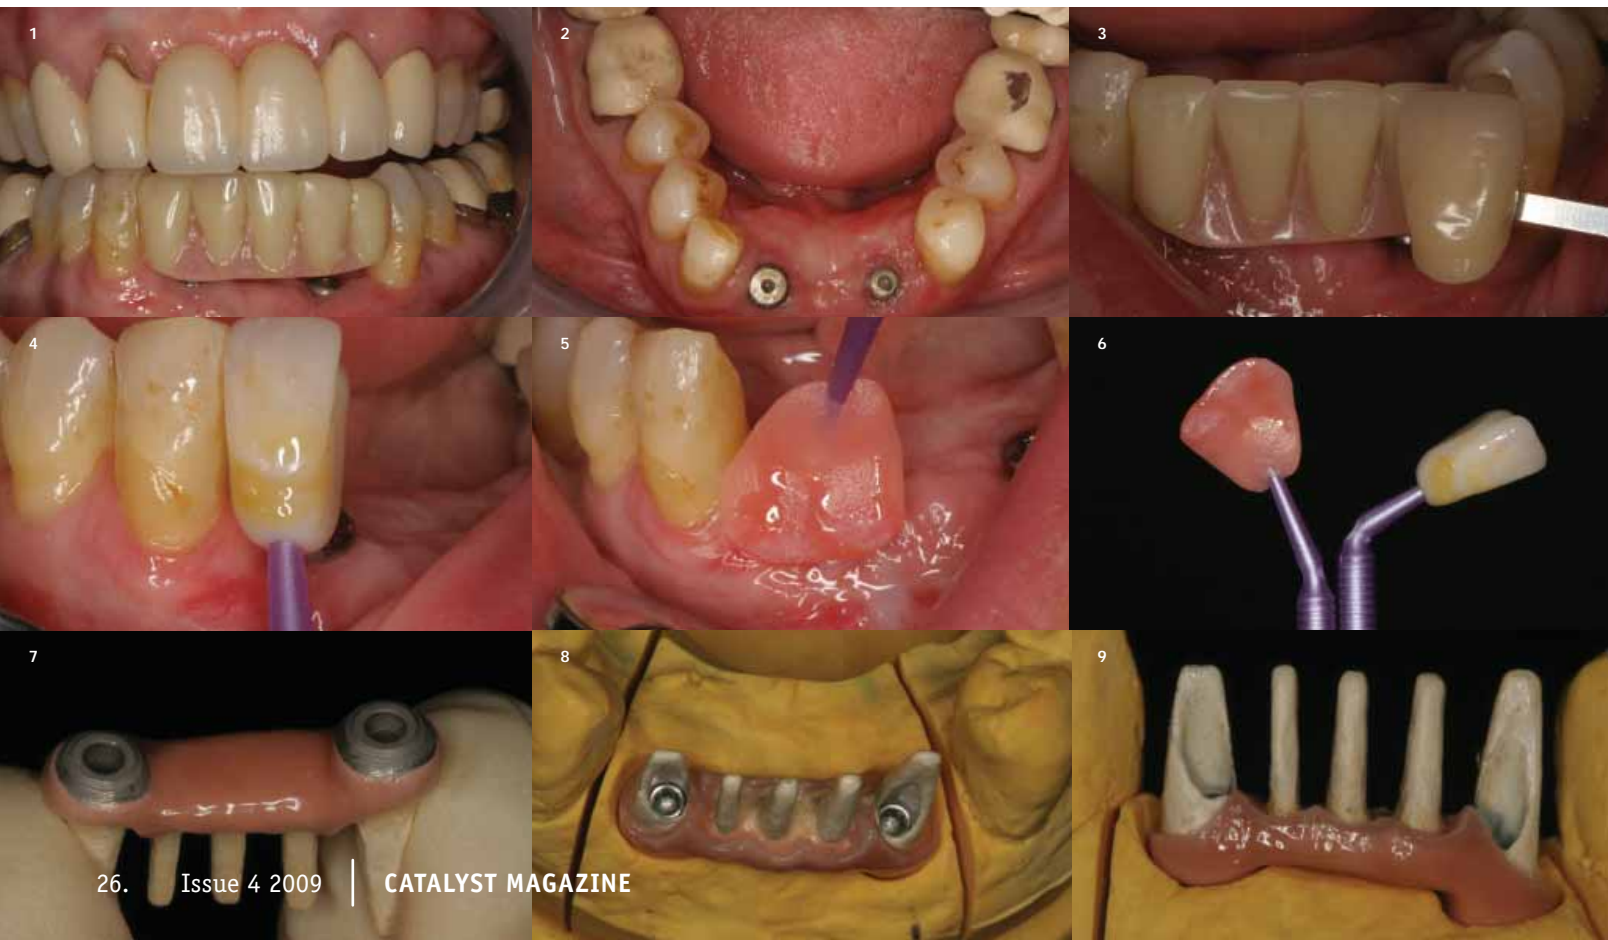
A metal framework was fabricated, and opaqued and pink gingival porcelain was placed with a flat contour, which interfaced tightly with the alveolar crest (Figure 07). This design had three major advantages: it allowed for easy oral hygiene, reduced the impaction of food during mastication, and made all subgingival margins screw retained, thus eliminating all subgingival cement margins as well as the need to remove subgingival cement. The final crowns were designed with the three center teeth as one unit that would ultimately be seated using a permanent resin cement (Kerr Maxcem Elite). The abutment crowns would be cemented with a temporary cement (Kerr Tempbond Clear), which would permit total retrievability of the restoration and allow for future repairs or modifications (Figures 08, 09 and 10).

The gingival tissues were cleared from the head of the implant fixtures with a tissue punch (Figure 11), and the restoration was tried and radiographed to ensure a precise

fit (Figure 12). The restoration was then removed, and the three "pontic" teeth were cemented with a resin cement (Figure 13). The abutment crowns were placed during this process to ensure the most precise alignment of all of the restorative pieces. It was important to check that the intraoral driver would fit between the seated pontic teeth and still align with the screw to full depth for torquing (Figure 14). The restoration was then resealed, and the final abutment screws were torqued to 25 N-cm according to the implant manufacturer's recommendations (Figure 15). The abutment crowns were then seated with temporary cement, which gave the entire restoration retrievability, while the strength and retention of the restoration was screw retained.

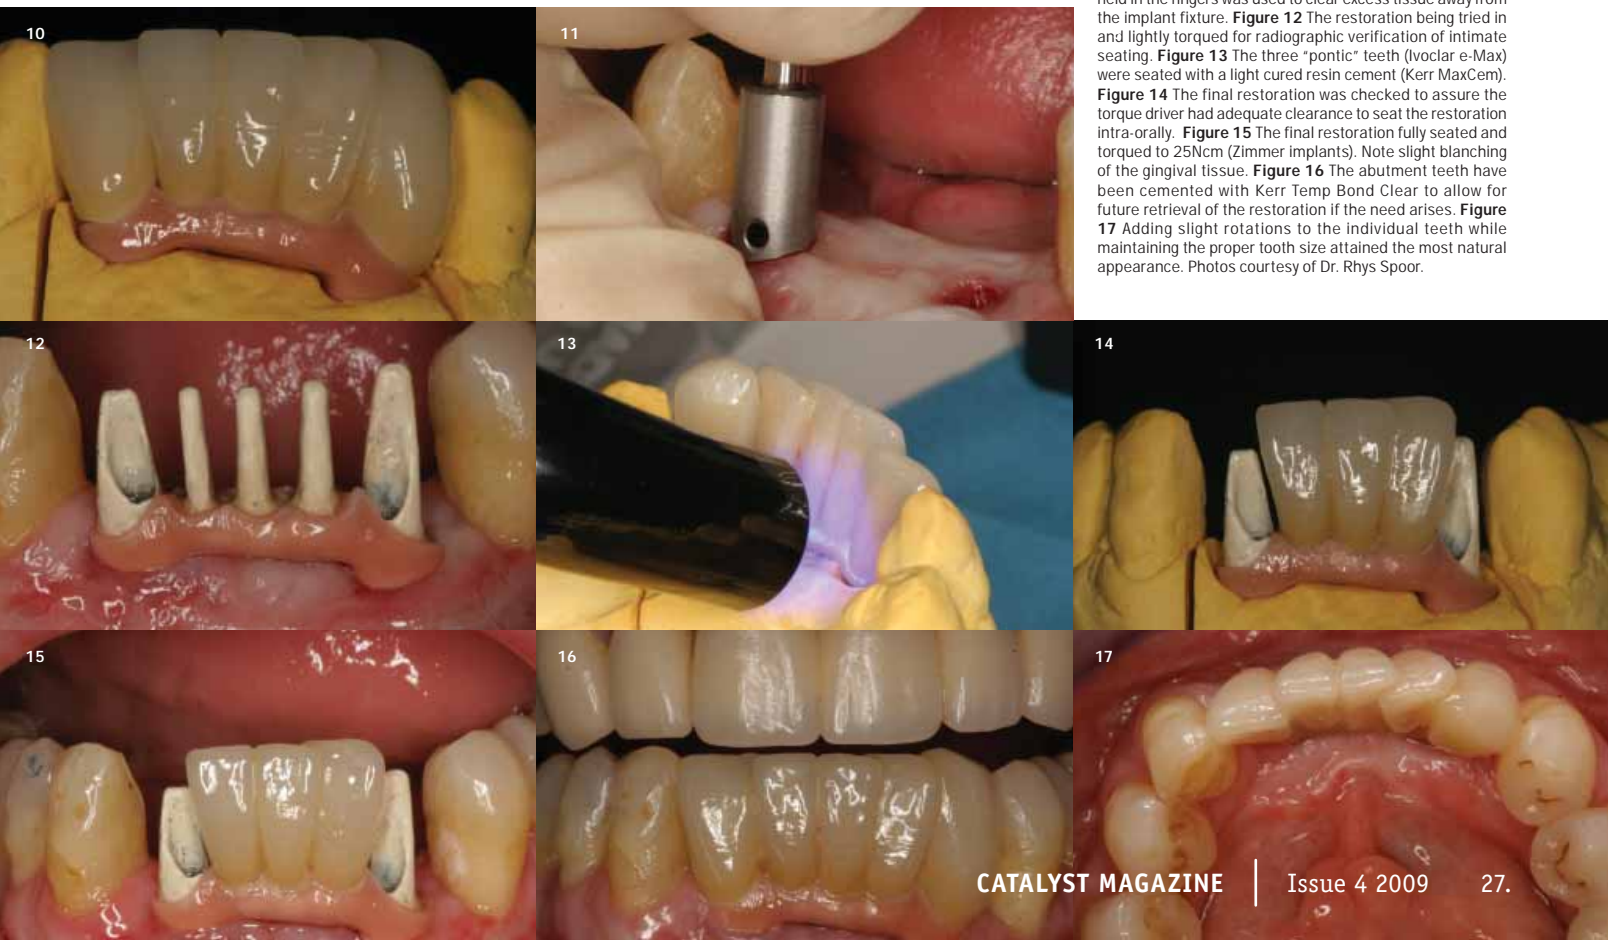
Left Page: **Figure 1** The patient after implant placement with removable temporary partial denture in place. **Figure 2** The arch form showed a deficiency of space for properly sized and spaced missing teeth. **Figure 3** Shade tab from Ivoclar Chromoscope shade guide showed the body shade to be 130. **Figure 4** Custom shade tab made from Kerr Premise composite and Kerr Kolor Plus composite tints. **Figure 5** Gingival custom shade tab made with Cosmodent gingival shaded composites and Kerr Kolor Plus tints. **Figure 6** Microbrushes were used to hold the custom shade tabs. **Figure 7** Gingival aspect of the restoration showing the flat interface with the alveolar crest. **Figures 8, 9 and 10 (Figure 10 This Page)** The final prosthesis on the laboratory model. **Figure 11** Nobel Biocare gingival tissue punch held in the fingers was used to clear excess tissue away from the implant fixture. **Figure 12** The restoration being tried in and lightly torqued for radiographic verification of intimate seating. **Figure 13** The three "pontic" teeth (Ivoclar e-Max) were seated with a light cured resin cement (Kerr MaxCem). **Figure 14** The final restoration was checked to assure the torque driver had adequate clearance to seat the restoration intra-orally. **Figure 15** The final restoration fully seated and torqued to 25Ncm (Zimmer implants). Note slight blanching of the gingival tissue. **Figure 16** The abutment teeth have been cemented with Kerr Temp Bond Clear to allow for future retrieval of the restoration if the need arises. **Figure 17** Adding slight rotations to the individual teeth while maintaining the proper tooth size attained the most natural appearance. Photos courtesy of Dr. Rhys Spoor.

The final photographs (Figures 16 and 17) show the restoration at three weeks after delivery, and indicate excellent gingival tissue blend and harmony with the adjacent dentition. By using creative design and technical precision, restorative
